DE VILLIERS CONDITION SURVEY REPORT ON:

Smith Street, London W1

PREPARED FOR: Mr & Mrs Smith

J Perris, BSc MRICS

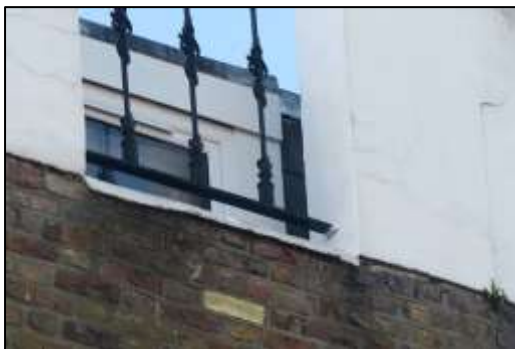
The main roof is of mansard design. The roof is not fully visible from our ground level inspection. It appears to be of imitation slate to the roof slopes and we assume under a flat roof crown.

Flat roofs are generally considered to have a relatively limited lifespan usually in the region of 10 to 20 years dependent on the material used.

It should be appreciated that most flat roofs do require periodical maintenance particularly around more vulnerable areas such as parapet walls to ensure watertightness.

In view of the limitations of our inspection it would be worth enquiring of the managing agents/freeholders to establish what works, if any, have been carried out on the main roof in more recent times. This should provide an idea as to the age of the covering and perceived future costs.

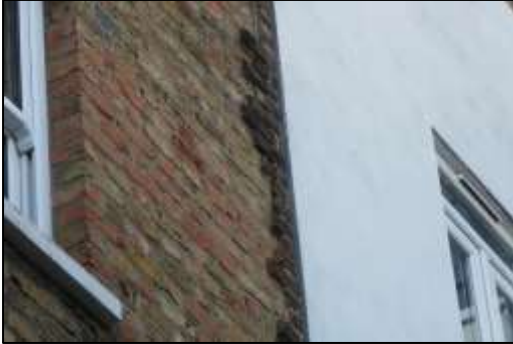
The building has been predominantly reconstructed and this is illustrated by the course of original brickwork along the line of the party wall to the rear which is no longer flush where the wall was rebuilt straight.

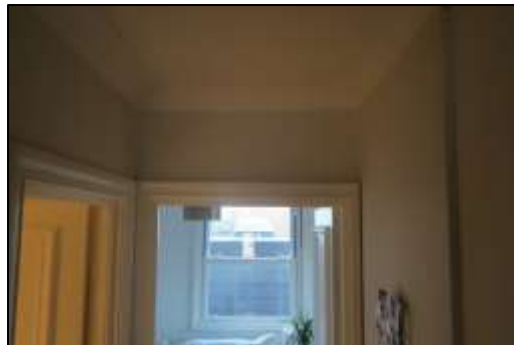
Where possible all areas were checked for signs of cracking and movement. There is some minor infilled cracks internally, movement around doorheads internally and some cracking is evident along the line of the party wall to the front. This movement is not considered of serious structural significance with no evidence of recent problems.

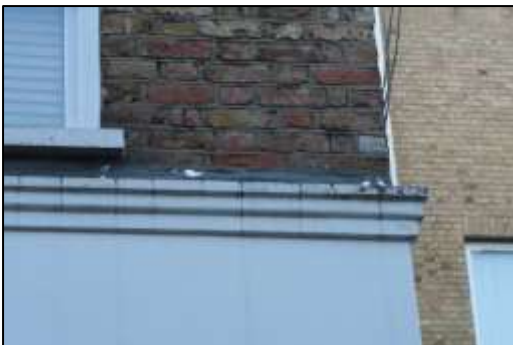
The detailing between the brick wall and lower levels of render has been patch repaired using a temporary “flashband”. These areas are generally vulnerable to water ingress as rainwater is trapped between the render and brickwork. Flashband is only a temporary measure and this should be properly dressed by a roofing contractor using lead.

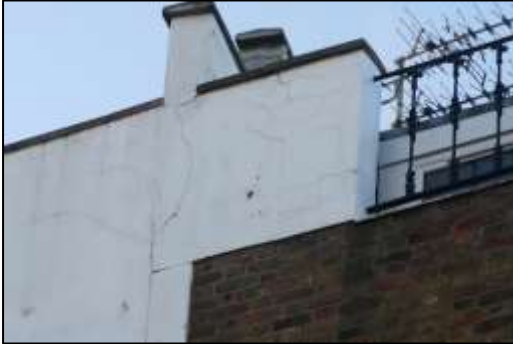
There is evidence of cracking and crazing to the rendered finish to the mansard floor. This render appears to have failed and will need renewing as part of routine maintenance. Parapet walls are prone to problems although the coping stones to the top of the wall will help to reduce water ingress and subsequent damage occurring.

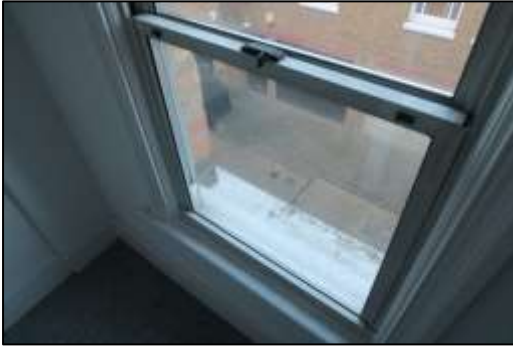
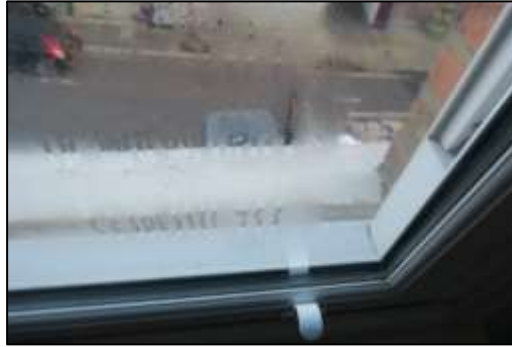
Generally these units were in reasonably good condition although we did note that there is evidence of condensation between the glass panels within the bedroom and kitchen. Double glazing usually has guarantees between 10 to 20 years and we would recommend the installers of these windows are called to further investigate to see which sealed units need replacement. If there are no such guarantees in place then estimates should be obtained from a window contractor.

Your Legal Advisers should check for the existence, validity and transferability of any guarantees particularly in relation to the double glazed units which have failed and the company must be recalled to undertake repairs.

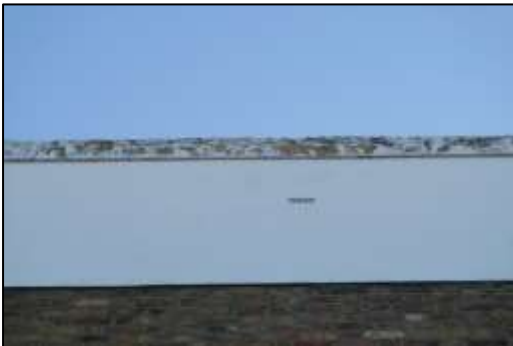
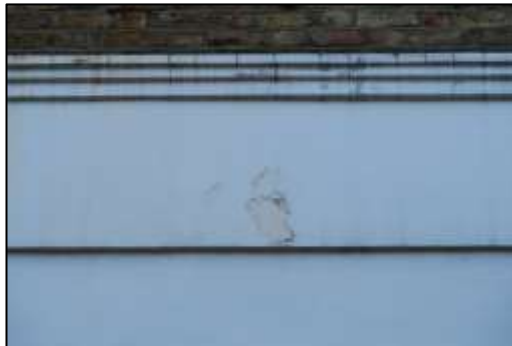
Localised external redecoration is now required. Enquiries should be made of the managing agents/freeholders to establish if a sinking fund has been put in place for external redecoration.

Redecoration should be undertaken at least every five or so years to ensure external building materials are fully protected.

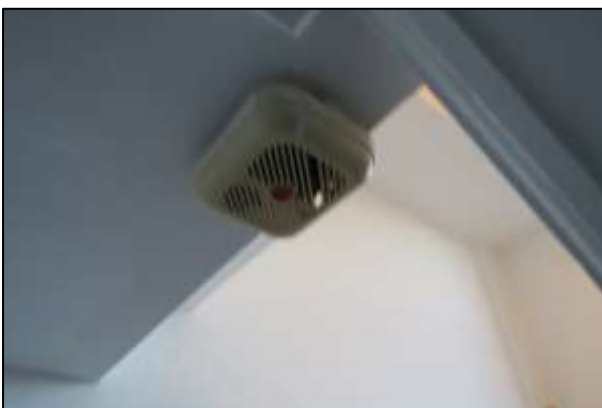
Communal areas are in fair order although will require some cosmetic improvement in the near future. The smoke alarm was also noted to be dated and should be upgraded to a mains connected system. See section under electrics.

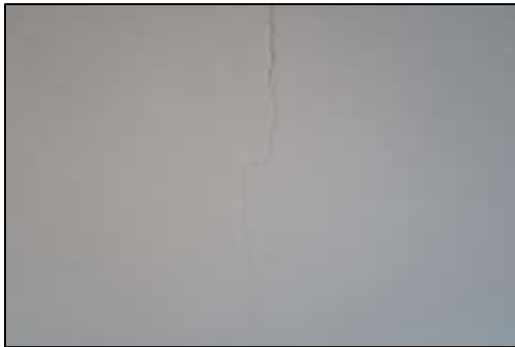
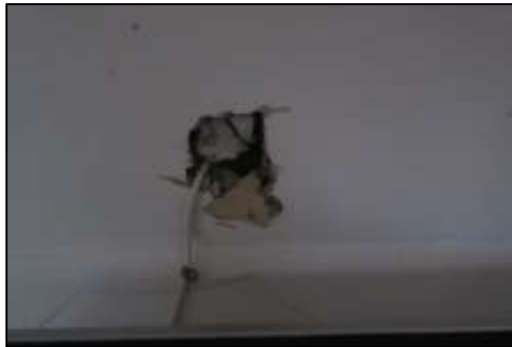
Ceilings are predominantly of plasterboard construction. With the exception of localised cracking which is not considered of serious structural significance overall ceilings were satisfactory.

Where a cable has been run through the ceiling within the bedroom cupboard this has been poorly finished and you may wish to have this repaired.

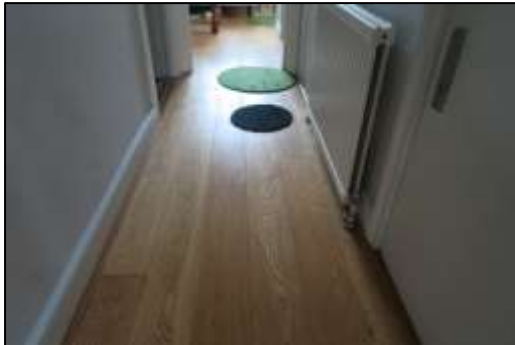
A timber floor finish has been provided to the hallway and reception room. These can often be prevented under the terms of a lease as a courtesy to the flat below. Legal Advisers should establish whether such flooring is allowed under the terms of the lease. It must be appreciated if there is no such restriction there is the increased risk of noise to the subject flat from the property above if they also adopt a wooden floor.

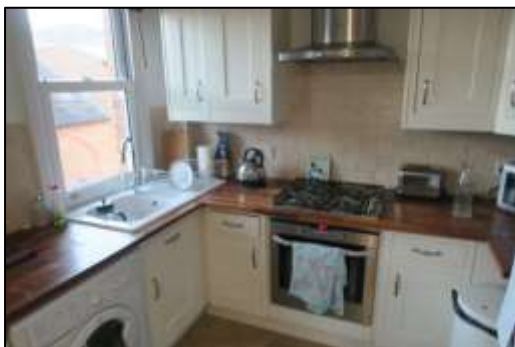
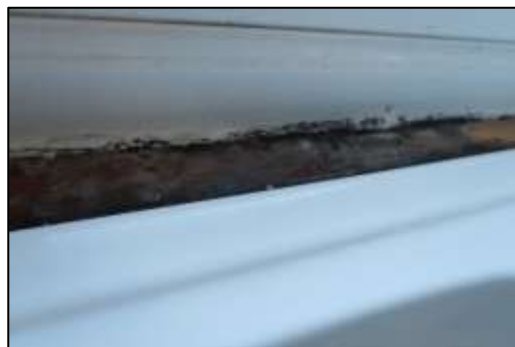
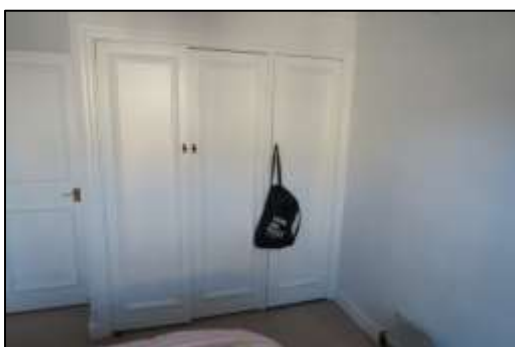
Kitchen units comprise a range of wall and base fittings. Whilst in fair order there is evidence of localised wear and tear as well as deterioration and water damage to the worktop not uncommon with these solid oak finishes.

The property is provided with a range of built in cupboards. Generally internal joinery, including internal doors, were now slightly dated and you may wish to carry out some upgrading.

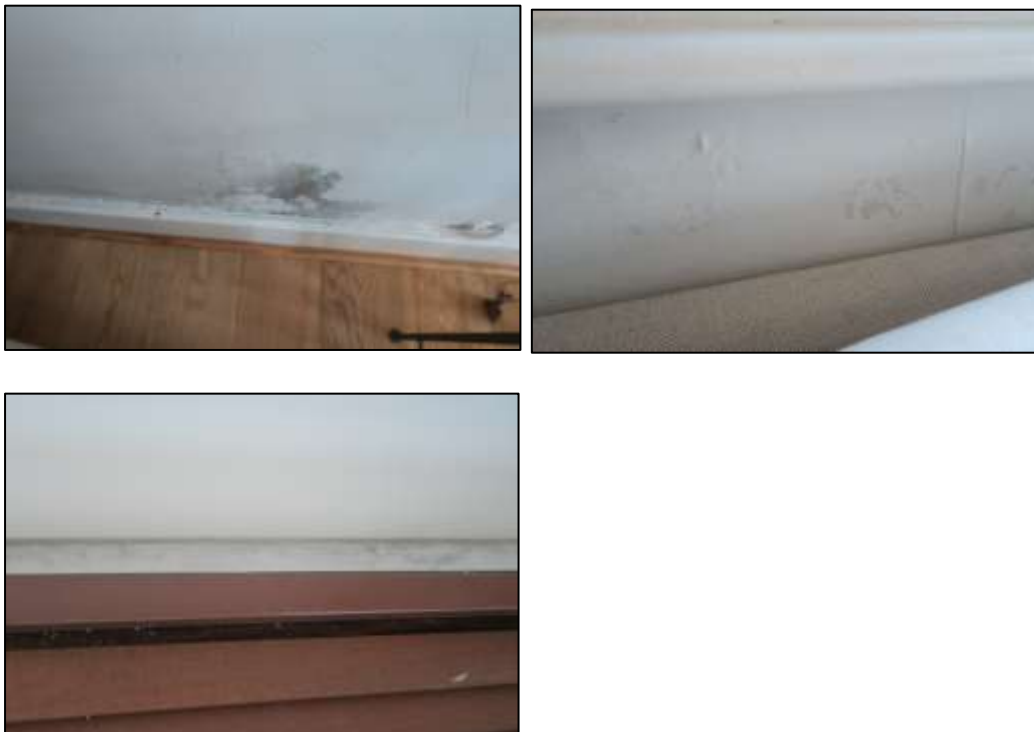
High damp meter readings were recorded below the window within the reception room. This would appear to be penetrative damp around the window and brickwork externally. There is no obvious cause of this from my inspection to the rear and we would recommend the matter is passed to the managing agents/freeholders to ensure localised pointing and sealing is carried out around the window detailing to prevent any further damp occurring.

Further similar damp was noted directly above the kitchen window we assume caused by a similar problem of window detailing.

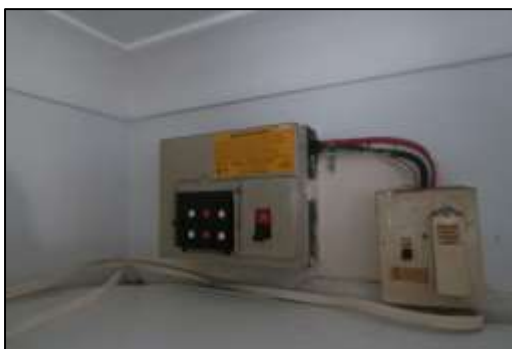
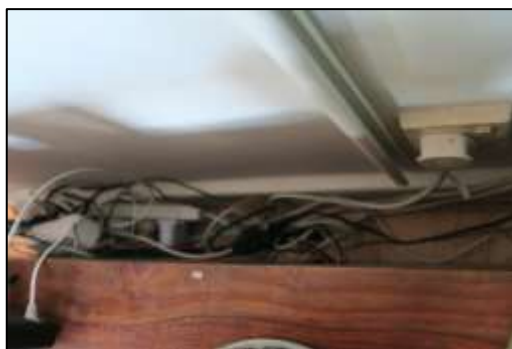
The property is connected to mains electricity with a consumer unit situated within the kitchen and the meter within the communal ground floor area. The consumer unit was dated with several older style fittings, no mains smoke alarms and an inadequate amount of outlets by today's standards. General rewiring works are now considered necessary and estimates must be obtained from an NICEIC registered electrician.

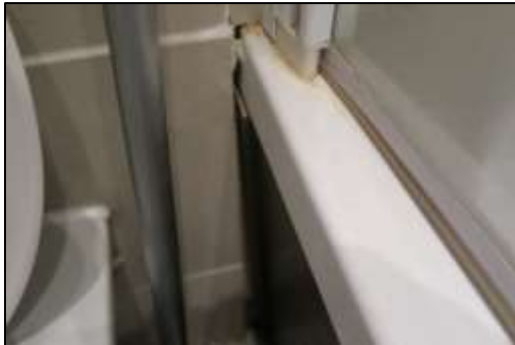
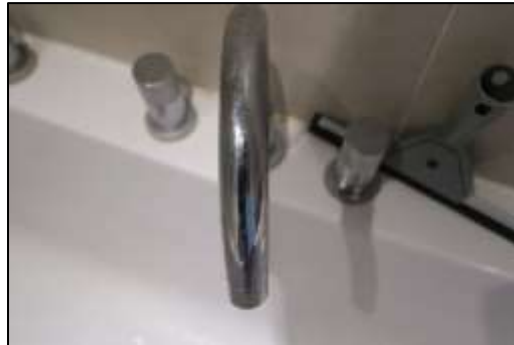
The sanitary amenities appear satisfactory although some of the tiling was noted to be below standard with the fittings to the bath beginning to seize slightly.

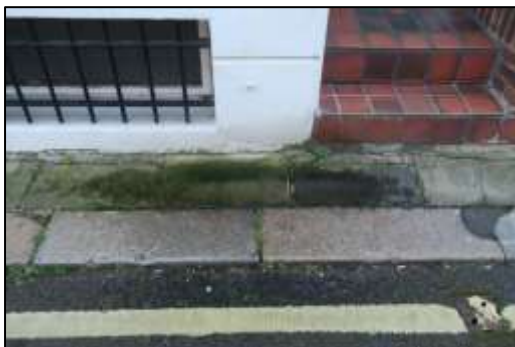
An overflow was leaking to one of the water tanks (it may not be the subject) resulting in water adjacent to the front door. This is usually caused by a failure of the ball valve to the tank and will eventually cause damp issues within the subject flat and should be repaired. Enquires should be made of the managing agents.

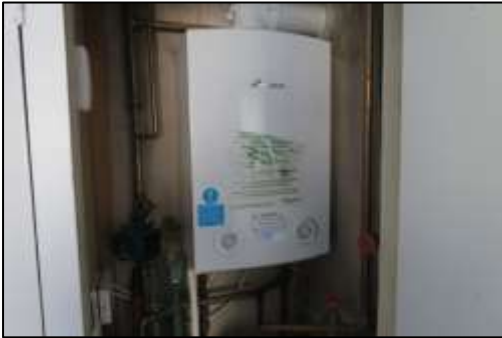
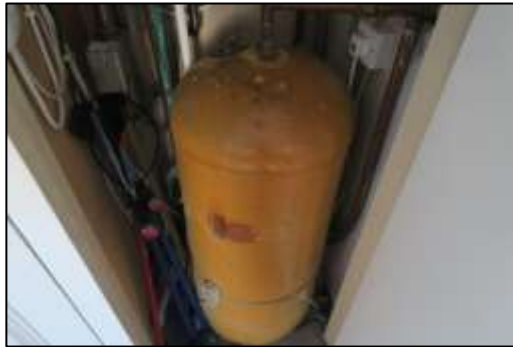
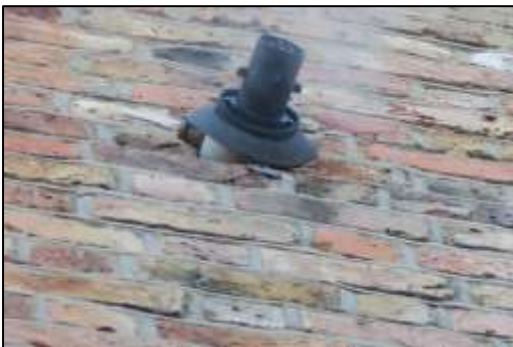
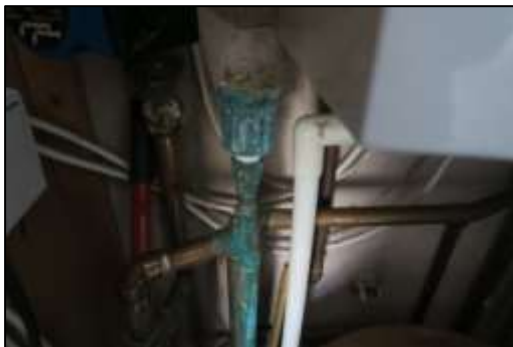
Gas radiator and central heating is provided by a gas boiler situated within the bedroom. Hot water is situated within an insulated tank directly below the boiler. Cold water is stored within a tank in the communal area. Areas of the fitting were dated including the thermostat, radiators and the hot and cold water tanks with corrosion evident around a valve around the boiler. On our inspection it was also noted that the second smaller bedroom window was open with the heating on full. This could potentially indicate the inability to control the temperature.

Externally the boiler flue has not been properly sealed.

We would anticipate the need for upgrading of the system possibly with the exception of the boiler although most flats of this size would have a combination system to do away with the water tanks. In addition the radiators should be replaced and new radiators installed with thermostatic valves to control temperature.

Estimates for upgrading the heating must be obtained from a Corgi engineer.

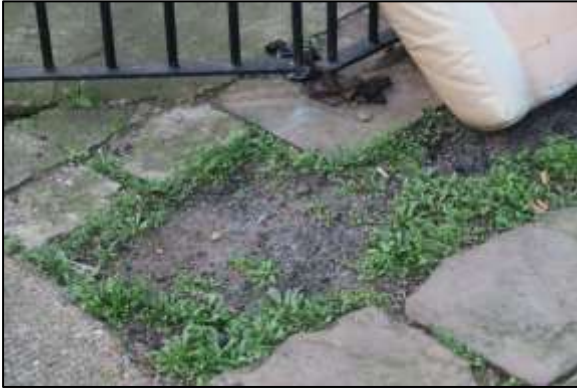
The property is provided with a small external area to the front which would benefit from localised landscaping although some of it may be the responsibility of the local authority.

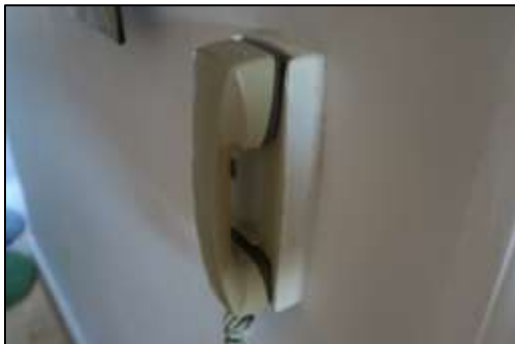
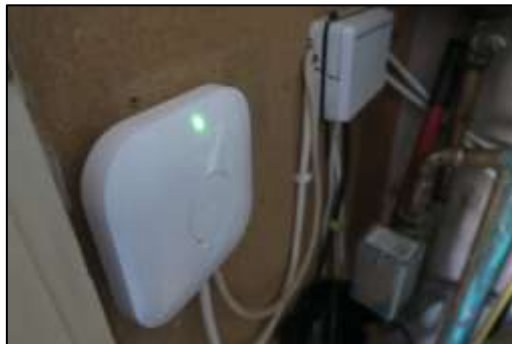
The property is provided with an entry phone system. This is somewhat dated and likely to require replacement in the near future. This is a cost which should be shared with the other occupiers of the building.

There appears to be a Nest security system in place. We assume this will be transferred to yourself and we would recommend you obtain details in relation to its operation.

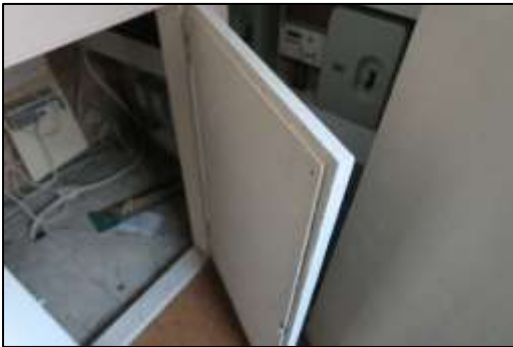
There is evidence of an asbestolux panel for the meters within the communal hallway. Whilst this is not believed to contain asbestos it would still be prudent that if it was removed or damaged that specialist advice is requested.
